# MORAVIAN GEOGRAPHICAL REPORTS

VOLUME 16

2008

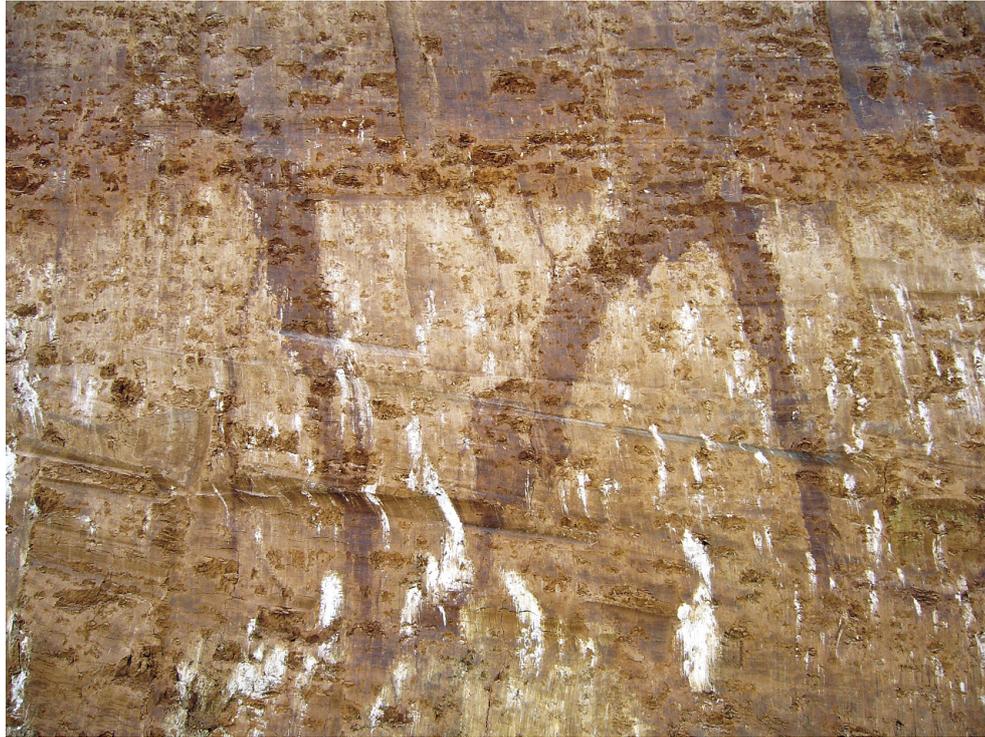
*Fig. 5: The net of Pleistocene ice wedge casts. Vertical cross section of the middle buried soil and connected ice wedge casts. Excavation of the road tunnel in Brno – Žabovřeská ulice Street (Photo J. Demek)*

During excavation works for a new tunnel in Brno – Dobrovského Street, Pleistocene ice wedge casts in loess were exposed in Žabovřeská ulice Street. These studies were carried out by Dr. Mackovčín (VÚKOZ), Dr. Kirchner (Academy of Sciences of the Czech Republic), Ass.Prof. Dr. Nehyba (Masaryk University), and by the author. The construction site is situated in the northern part of the City of Brno at an elevation of 240 meters a.s.l. In one stratigraphic profile, several superimposed paleosoils were found and with them connected nets of ice wedge casts originating in different phases of the Pleistocene. The nets of ice wedge casts were exposed in vertical and horizontal cross sections (Figs. 5 and 6).

The lower part of the exposure in Fig. 8 is still frozen (permafrost) with pure veins of underground ice. In the upper part, due to local permafrost degradation, the ice wedge melted and the space left after ground ice was filled by black loam. Ice wedges grow preferentially in fine-grained material (as is the case of exposures in Brno – Dobrovského Street tunnel – Figs. 5 and 6); they are best preserved in sands and gravels (as in Fig. 8).

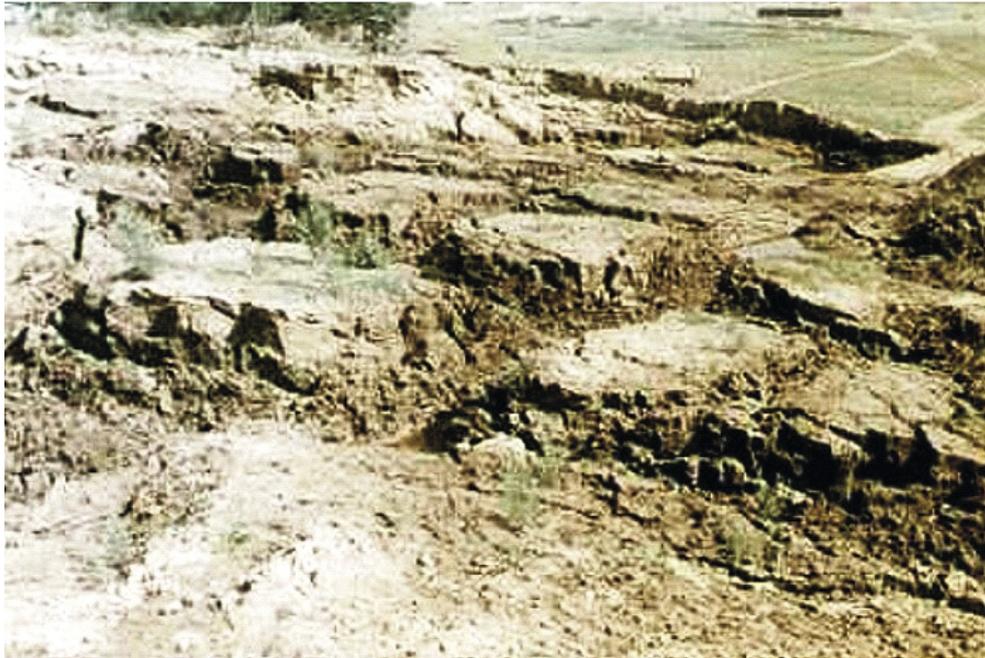
*Fig. 7: An example of the local degradation of recent permafrost with a net of ice wedges and origin of the net of pseudomorphs of ice wedges (ice wedge casts) in Siberia (Central Yakutiya near the town of Tommot - Photo J. Demek)*

lower altitudes of the Czech Republic. Ice wedges require certain temperature conditions for growth and preservation. The mean annual temperature (MAAT) during the aggradation of permafrost and origin of the ice wedges net was approx.  $-6$  to  $-8^{\circ}\text{C}$ . Upon climatic warming and thawing of permafrost, the site of an ice wedge is filled with the collapsed material that becomes a cast of the wedge. An example of recent local permafrost degradation and formation of ice wedge cast in loess loams of Siberia is in Fig. 7.

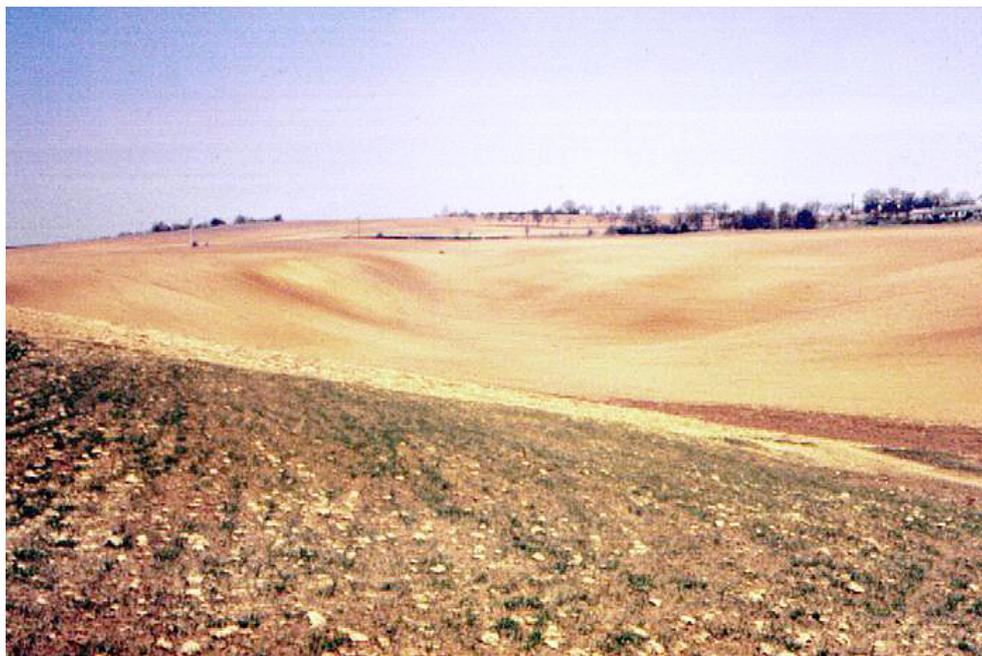
Fig. 2: The Luskovica dry valley head state in the 1990s (Photo M. Stankoviansky)

The dry valley basin under study is situated in the western part of the Krajné cadastral area. It is deepened into the left side of the Jablonka River valley (Fig. 1). The basin area is 52.9 ha, its longitudinal axis being 1,430 m in length, its maximum width reaching 510 m and depth roughly 30–60 m. The basin is built of a complex of Eggenburgian sandstones and conglomerates. Prevailing soil types are Albic Stagnic Luvisol and Haplic Planosol. Paradoxically, the valley bottom is broadening upslope, being broadest (45 m) in its kettle-like head (Fig. 2). Two dells enter the kettle, which are source areas of the prevailing amount of the valley bottom fill.

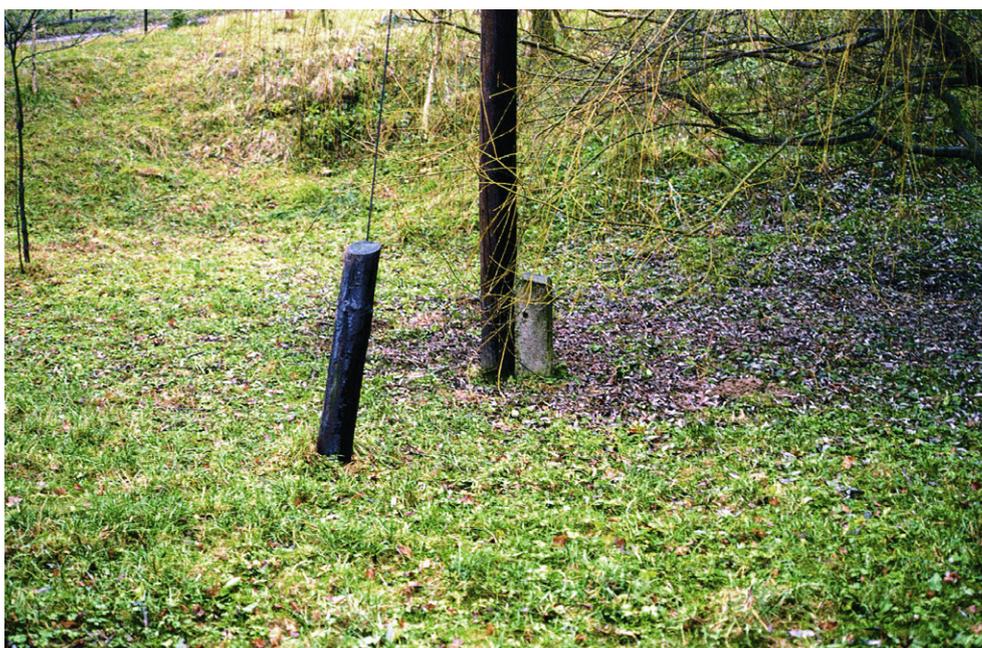
Fig. 6: A partially buried telephone pole on dry valley bottom at the hamlet of Luskovica (state in the 1990s - Photo M. Stankoviansky)

Lower situated deposits, laid under the influence of artificial barriers in the built-up part of the hamlet of Luskovica, are obviously mostly post-collectivizational. Interviews with local residents confirmed the hypothesis. According to them, the original, pre-collectivization valley bottom between the field of Korytárka and the built-up part of Luskovica hamlet had a rounded, dell-like cross-profile, while at present it is flat and markedly raised. The result of repeated accumulation is a layer of the youngest deposit, thickening downwards. It is indicated by another probe (excavated also in the pioneer phase of investigation) located directly in the built-up part of the hamlet about 170 m below the probe at the plum tree. Preliminary results of an interpretation of just this probe became a stimulus of the current research stage. The pit was excavated in the third of mentioned flat steps of the main accumulation body. This step originated due to a barrier represented by a low dike of the local road crossing obliquely the valley bottom. At this place, the valley bottom has a trough-like cross-profile, suggesting a former deeper cut. The thick layer of the young accumulation at this site was indicated originally by a partially buried wooden telephone pole fixed to a concrete pillar (Fig. 6 – by the way, the original telephone pole was substituted by a new, concrete pole in the meantime). The first estimate of the thickness of this deposit, made on the basis of ascertained dimensions of the concrete pillar, its burial by sediments (it stuck out less than 60 cm) and its comparison with other telephone

poles in the near surroundings that were not buried, was approximately 1 m (Stankoviansky, 1997). The pit at the telephone pole made it possible to identify nine sediment layers of thickness ranging from 3 to 19 cm, separated by the thin intercalations of organic matter (decayed grass), while the total thickness of the deposit was 105 cm (Fig. 7). We suppose that these layers correspond with nine erosion-accumulation events or in other words with nine muddy floods that occurred at the place after 1961, when the telephone pole was erected. Thus, this deposit is unequivocally of the post-collectivization age (Stankoviansky et al., 1999). As this pit was excavated and interpreted in June 12, 1996 and there were no fresh deposits in the site, the muddy floods had to occur in the period 1961–1995. The repeated occurrence of muddy floods at the hamlet of Luskovica and the accompanying elevation of the valley bottom resulted in a significant change in its geometry. It was not changed only at places where yards of two houses, standing just on the way of this element, were situated. Mud deposited on yards was at all times removed by people living there.

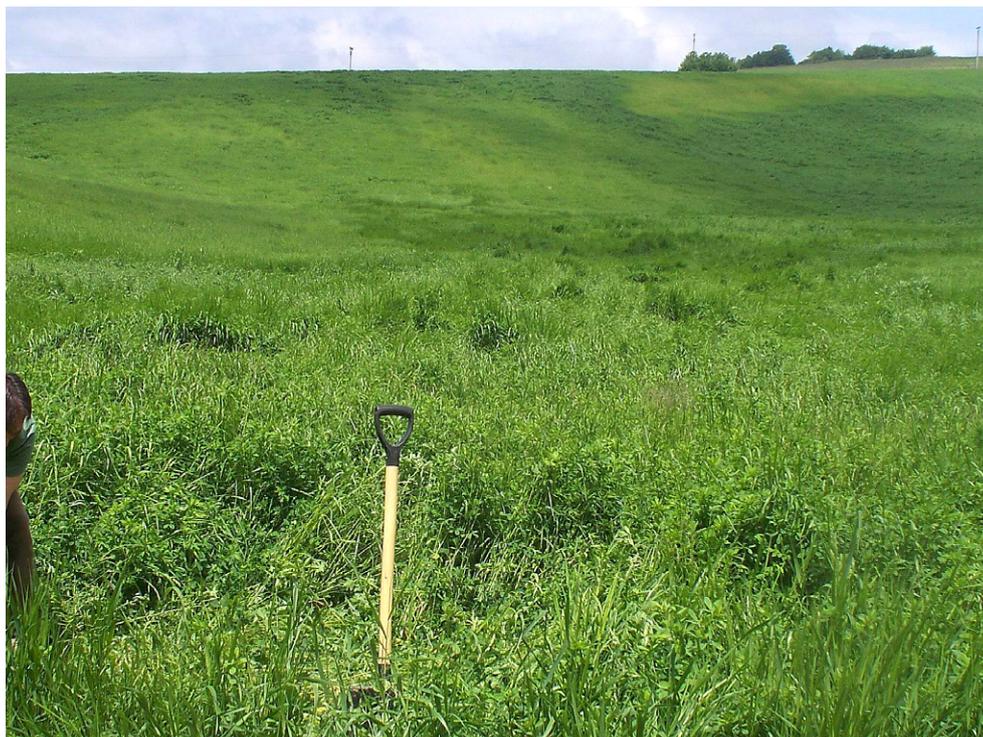
Fig. 8: Probing works in the upper part of the dry valley (Photo M. Žiak)

of flat steps both in the kettle-like valley head and above the contact of the field with the orchard situated at its lower margin (Fig. 8).

The pits as well as cores sampled by drilling from their bottoms showed that the valley floor fill up to a depth of 2 m is not stratified as the soil samples did not differ. We identified neither buried soil no any layer that would be able to distinguish the pre-collectivization body from the

post-collectivization one. This obviously relates to the fact that the sediment was homogenized due to both pre- and post-collectivization ploughing. To be able to find such traces, we plan to do more detailed probing works using an excavator and to open longitudinal and cross profiles (trenches) instead of point pits.

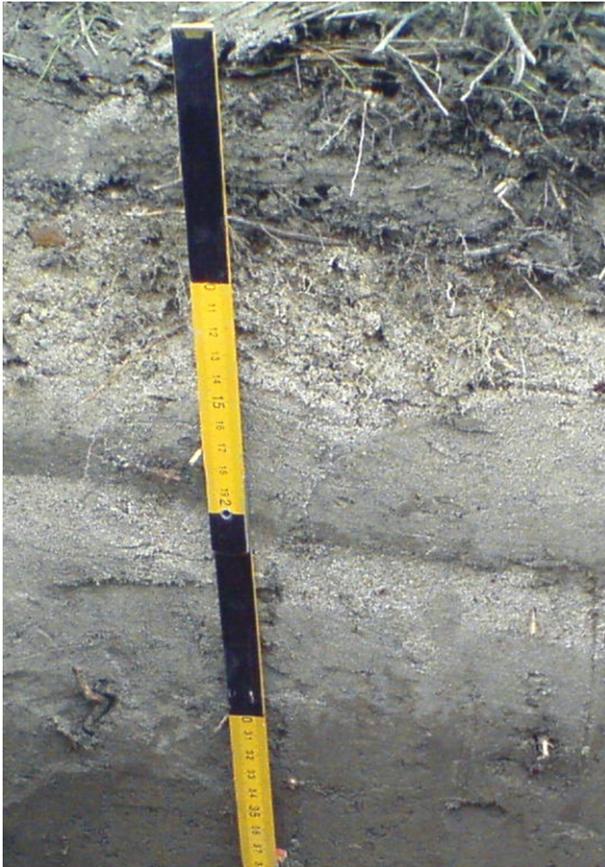
Fig. 5: The roof of the natural levee overbank deposits structure

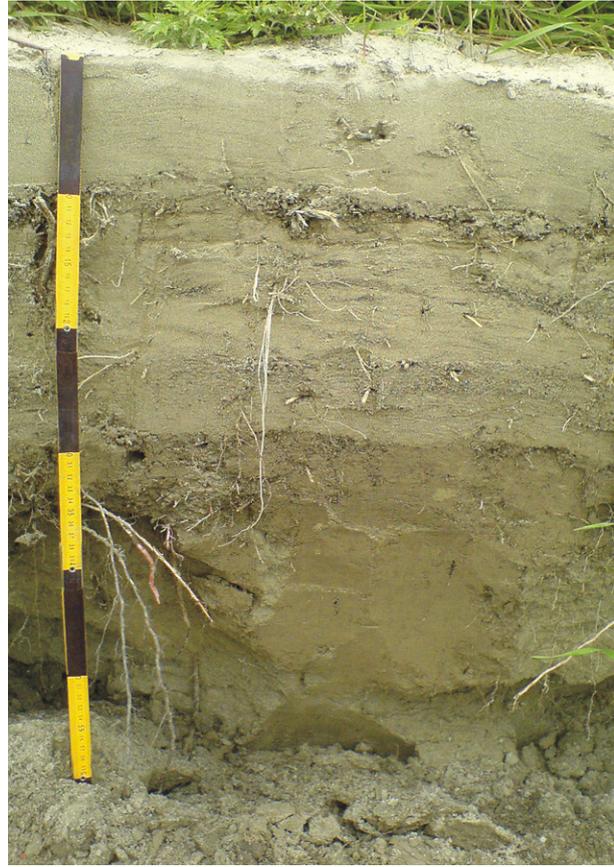
Fig. 6: The outcrop of channel overbank deposits

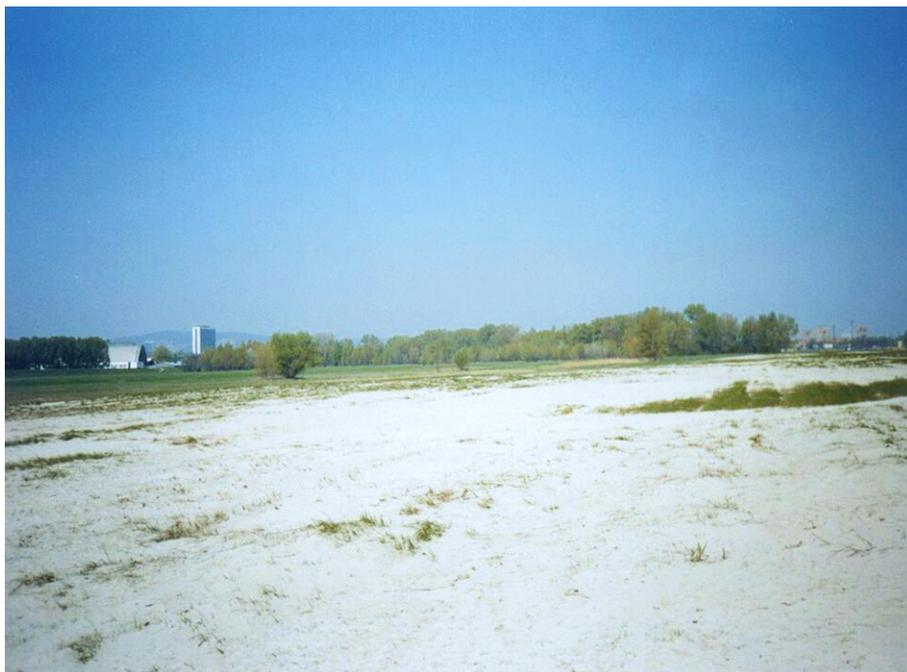
Fig. 7: The sandy cover deposited on the natural levee during the floods in 2002

The large sandy sheet of overbank deposits was accumulated on the natural levee during the two floods in 2002 (Fig. 7). However, during the 2007 summer flood, small-sized and episodic landforms were deposited such as: sandy ribbons, sandy shadows, small-area sandy sheets (Fig. 8). The structure of alluvia deposited on the levee by the 2007 flood as a lithofacial profile is shown in Fig. 9A. We recognised two three-unit sequences making up the record of three flood phases on this profile. They are deposited above massive silt with isolated pebbles. The similar flood cyclotheme of overbank deposits was found on the bank profile (Fig. 9B). It is possible to identify three units of different lithofacial features in each of these layersets:

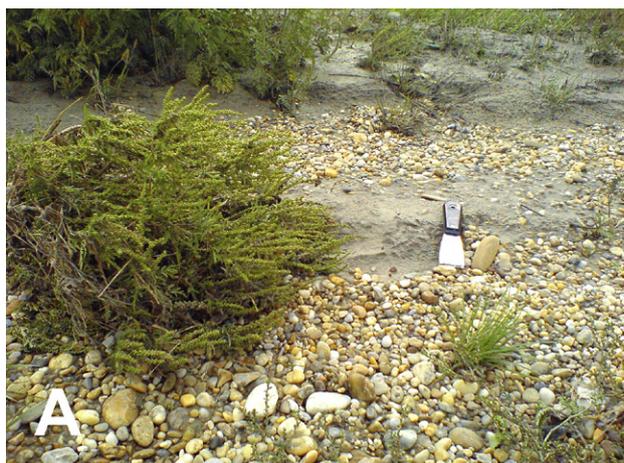
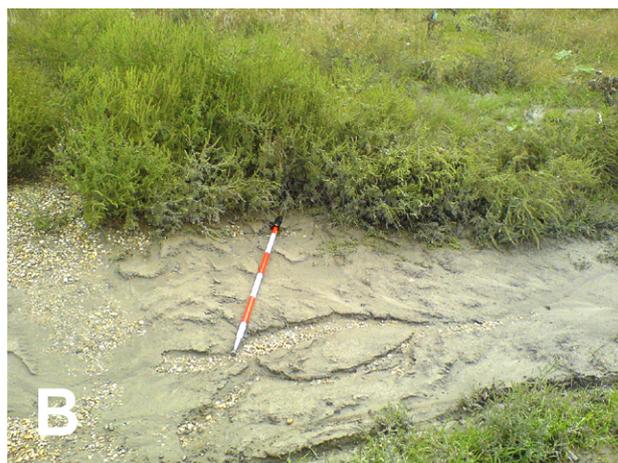
Fig. 8: The forms accumulated during the 2007 flood: A - sandy shadow and ribbons, B - small-area sand cover

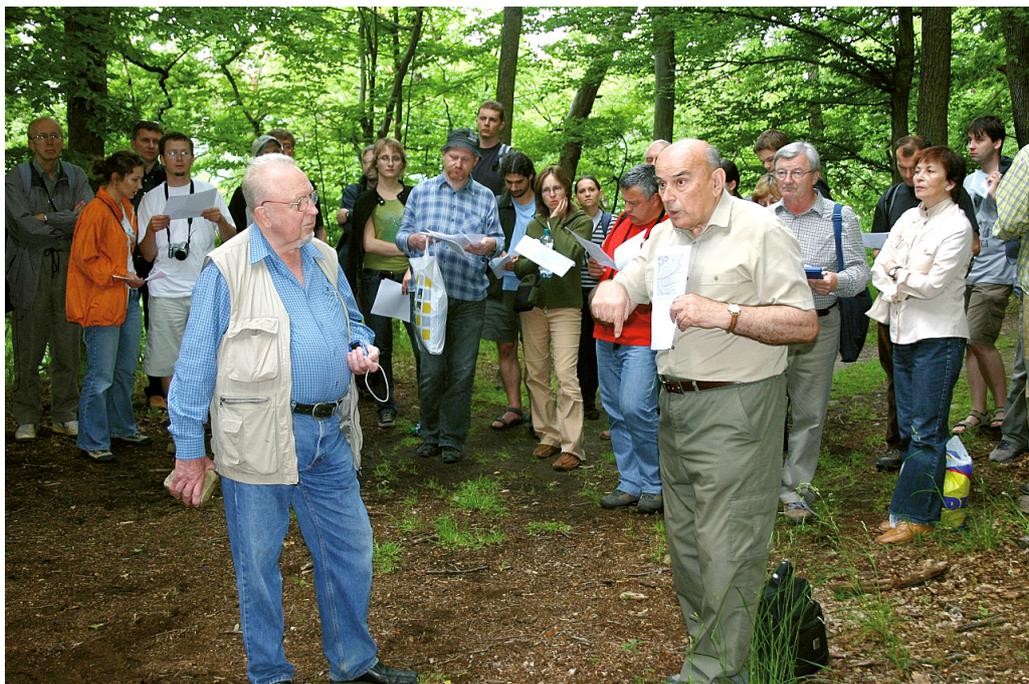
*Professor Jaromír Demek is explaining the geomorphological development of the Dyje River in The locality of Ledové sluje (Ice caves) in the Podyjí National Park during field excursion (Photo: M. Havlíček)*

On the third day of the conference, a field trip was organized by coach to three localities southeast of Brno at the margin of the Bohemian massif. The first visit was paid to the locality of Ledové sluje (Ice Caves) with outstanding deep-seated slope deformation and pseudokarst features and discussed were also the problems of the Dyje river development. In the following locality of Hostěradice, the conference participants visited medieval cellars excavated in the Lower Miocene sandy marine deposits, where new findings on morphotectonics of the area were presented. Visit to the last locality was devoted to the relationship between Miocene marine transgressions and landscape evolution in the Vedrovice locality where outcrops of the marginal facie of Lower Miocene sea were shown to the participants.

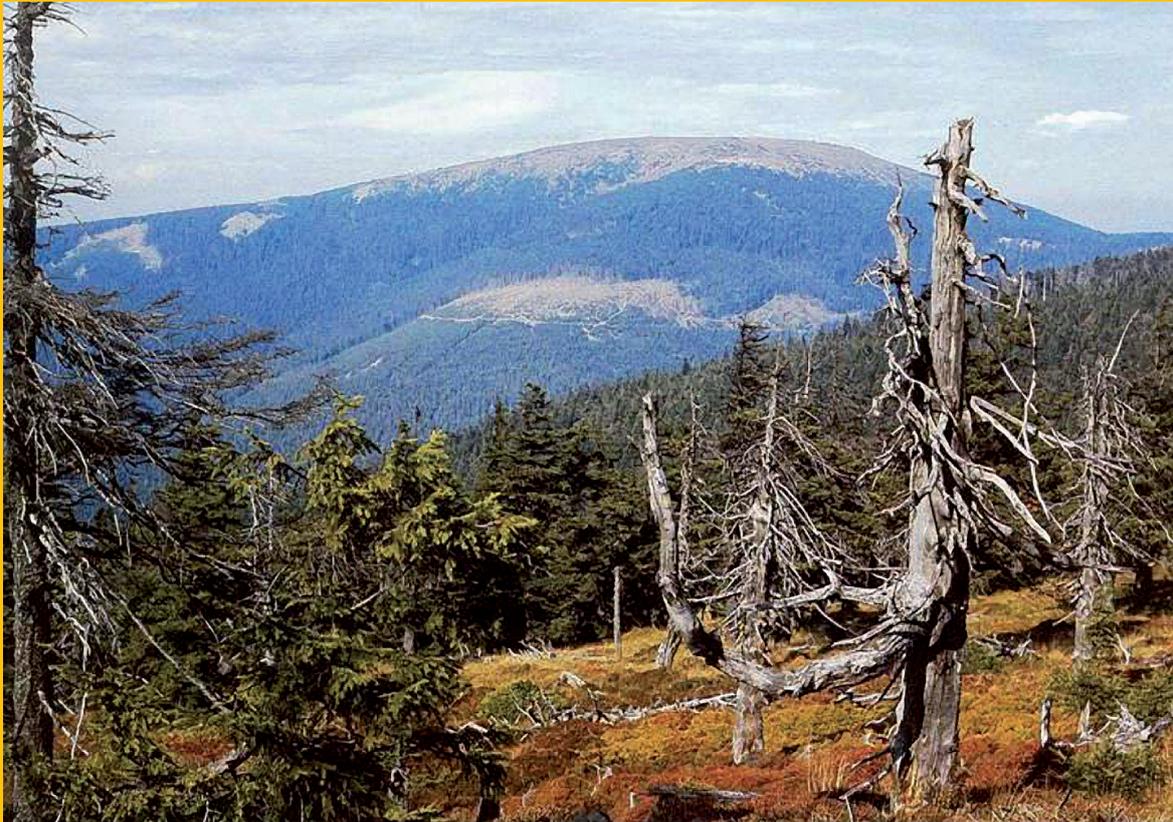
*Fig. 2: The impact of altitude on vegetation on the slopes of Králícký Sněžník Mt. (1423.7 m a.s.l.). The top of the mount reaches above the upper timberline (source: Archive VUKOZ)*

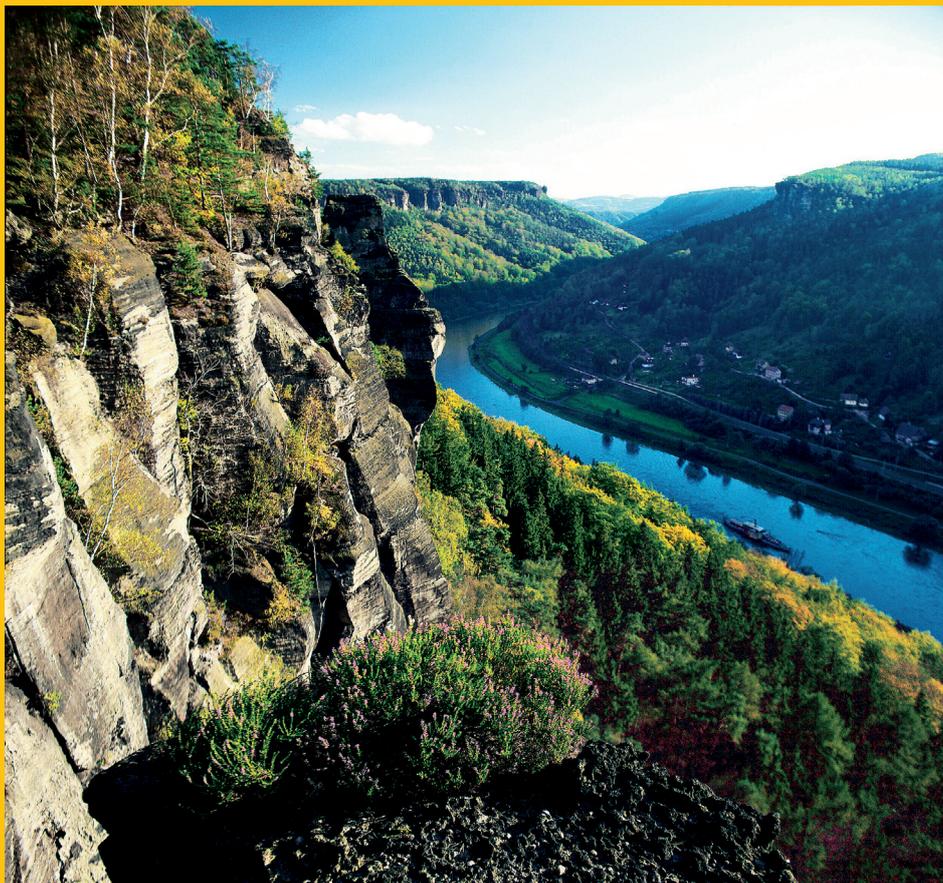
*Fig. 3: The Labe R. canyon through the Děčínská vrchovina Highland with the developed valley phenomenon (source: Archive VUKOZ)*

In the horizontal dissection of the landscape, rivers and their valleys play a great role. Some organocomplexes developed on water divides and flat planation surfaces and others in valleys, especially in deep incised river valleys. A so-called valley phenomenon developed in the deep incised valleys of the Vltava and Berounka R. in Central Bohemia, in the canyon of the Labe R. in the Děčínská vrchovina Highland or in the deep meandering valley of the Dyje R. in the SE part of the Bohemian-Moravian Upland. On a stretch of some tens of meters, there is a large difference of ecological conditions between the flat planation surface just above the upper rim of the steep valley side, where the surface air temperature is higher than 50°C, and the cold bottoms of deep valleys, where the temperature inversion occurs. The river valleys are also important migration corridors. Especially under the impact of global warming, submontane species use river valleys to migrate into the mountains.
